U.S. ARMY COMBAT SYSTEMS

"VEHICLE TEST COURSE SEVERITY"

Test Operations Procedure 1-1-010

VEHICLE TEST COURSE SEVERITY

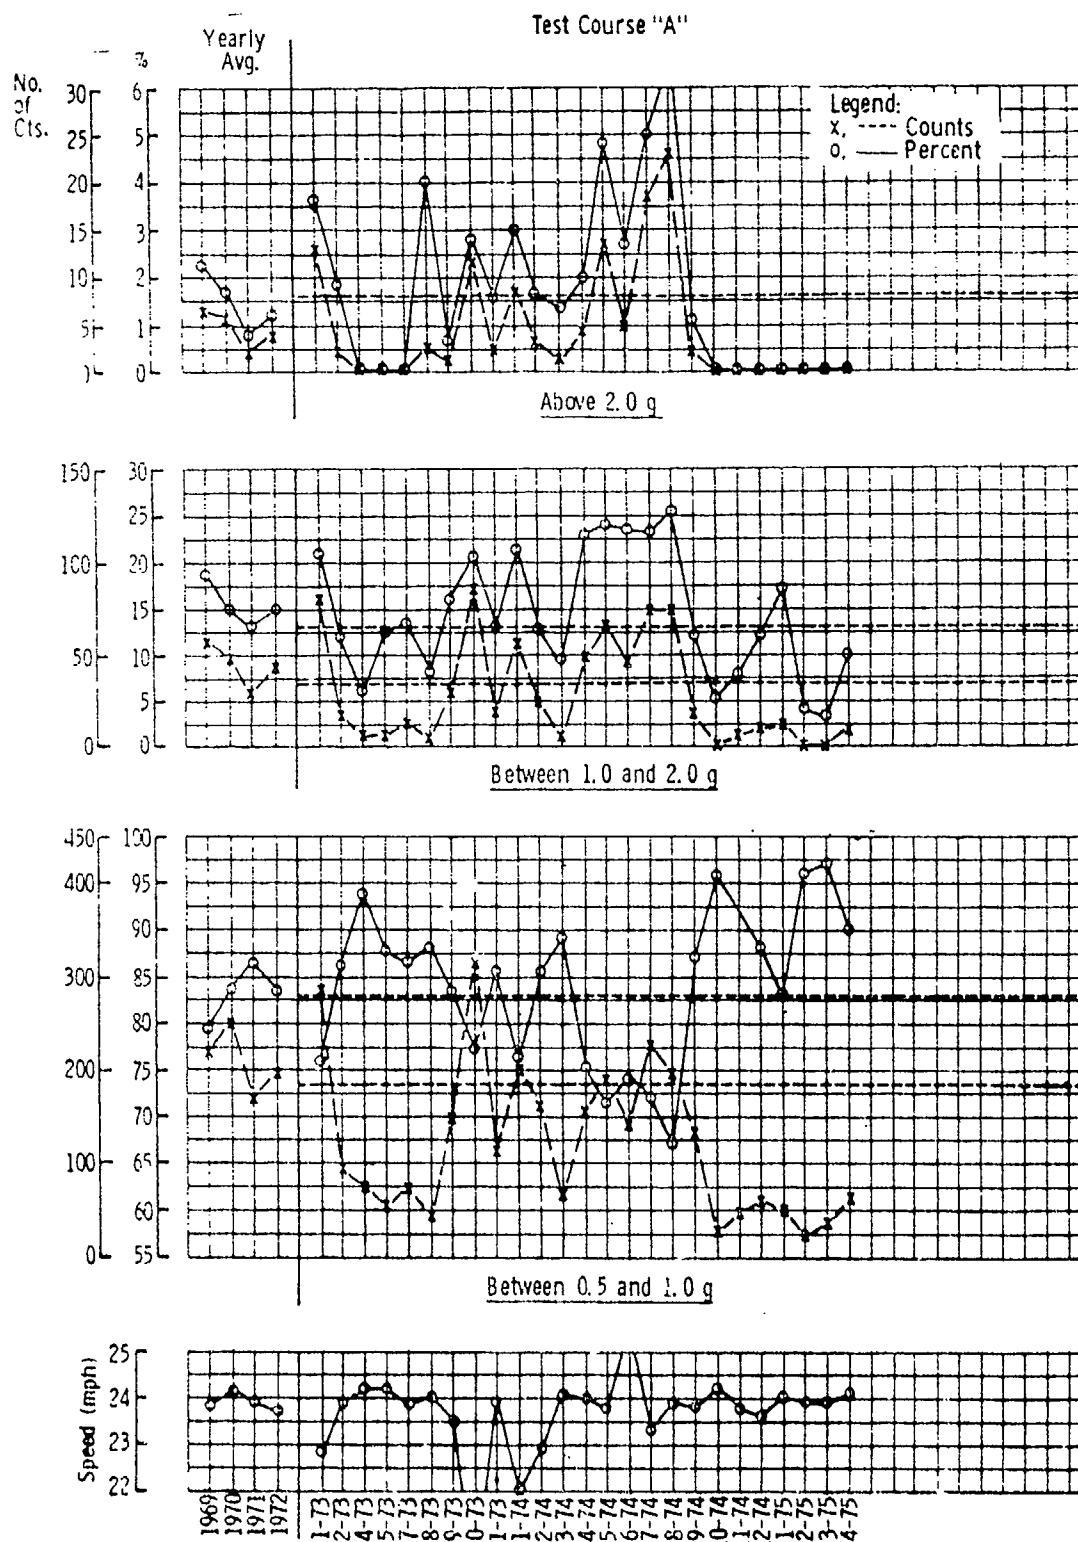
Figure 1. Typical test course quality control chart.

For a given course, a vehicle with a different wheelbase will behave differently and will produce a different measurement. Vehicle speeds and accelerometer count control limits for each course are shown in Table 1. The time to traverse each course and length of each course are recorded for use in computing the average course speed. These data are plotted on the test course quality control chart (fig. 1)² to identify course severity with respect to established upper and lower control limits for each g-range count and previous inspections. In addition to

the number of counts for each g range, the percentage of the total g-count distribution for each g range is shown. The quality control charts are used in conjunction with the committee's assessment of course conditions to determine the cause of significant changes in course severity and maintenance necessary to bring the severity level to within its control limits. In some cases, it may only be necessary to deepen or fill in certain potholes/ruts; in other cases, complete regrading may be required.

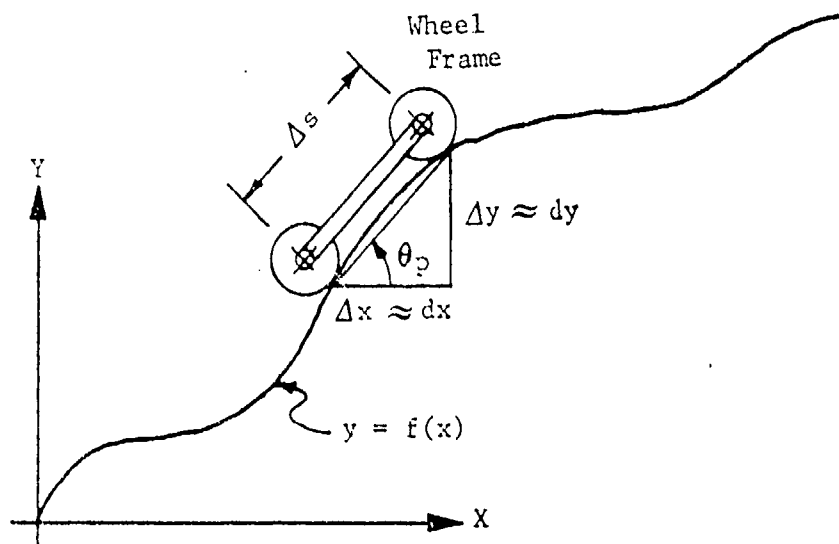
4.1 Course Profile Geometry. A course profile can be represented by cartesian coordinates, with y depicting course height and x, the horizontal distance traveled. To measure these parameters, a small wheel frame is towed over the course. In Figure 2, the symbol θ_p is approximately equal to the angle of inclination of the curve, $y = f(x)$. ^PNOTE: If the base of the wheel frame is small (approaching 0), θ_p would equal the actual angle of inclination. $\sin \theta_p = \Delta y / \Delta s \approx dy/ds$ and $\cos \theta_p = \Delta x / \Delta s \approx dx/ds$ in which s is the distance traveled along the curve.

Figure 2. Course profile geometry.

The desired x,y parameters can now be obtained by integrating as follows:

$$\int \sin \theta_p ds = y \text{ (height)}$$

$$\int \cos \theta_p ds = x \text{ (distance)}$$

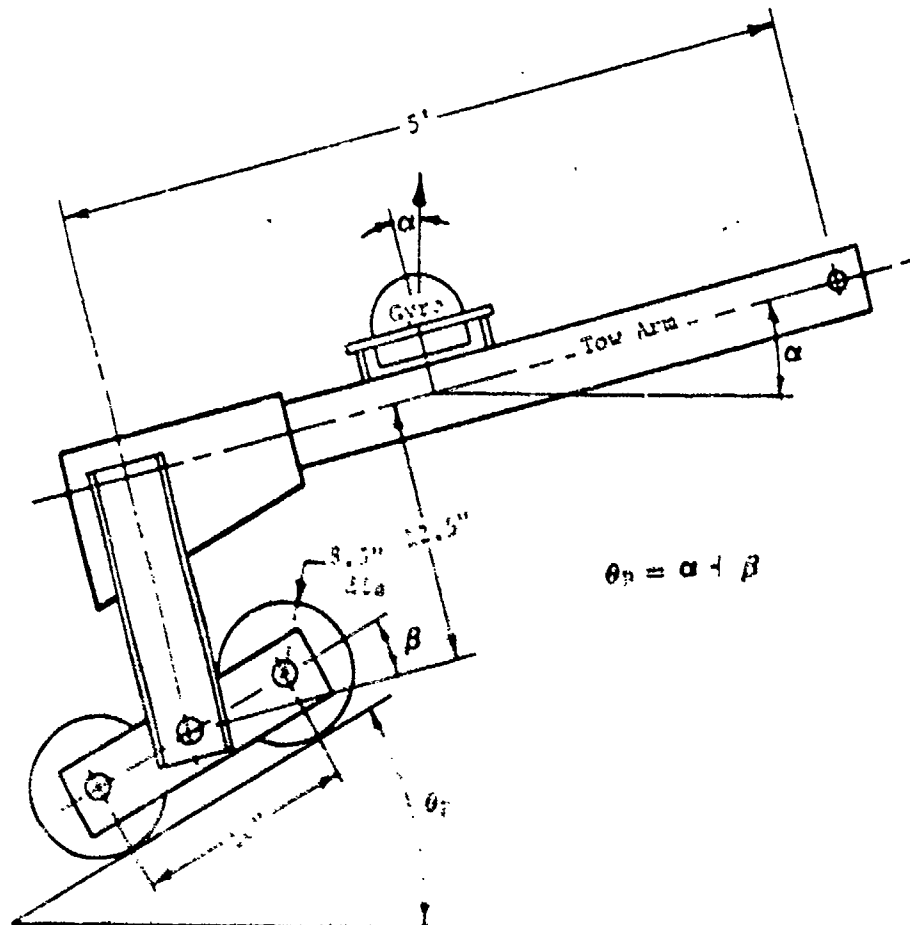
4.2 Profile-measuring Equipment. Test course profiles are measured with a profilometer system which consists of a tow arm, data-acquisition subsystem, and mobile mini-computer-based data analysis system. The profilometer tow arm (see fig. 3) obtains the slope of the test course and distance the wheel frame traverses the test course. The data are processed and stored by the microprocessor-based data-acquisition subsystem. Analog data are conditioned, filtered, and digitized. The microprocessor transforms digitized data points into instantaneous slope data and stores the solutions in bubble memory. These data are then transferred to the data analysis system for processing. This system produces PSD, amplitude distribution, and x-y coordinate plots of the terrain profile. Because the data are computer-based, a wide variety of analyses can be readily obtained.

A two-axis, vertical gyro with a potentiometer on the pitch axis is used to indicate the pitch angle (α) of the tow arm. The angle of the wheel frame relative to the tow arm (β) is indicated by a relative angle potentiometer. These angles added together form the angle of the terrain relative to the horizontal ($\alpha + \beta = \theta$). Horizontal orientation is indicated by 0 volts; positive angles are indicated by positive voltages, and negative angles by negative voltages.

Figure 3. Profilometer tow arm geometry.

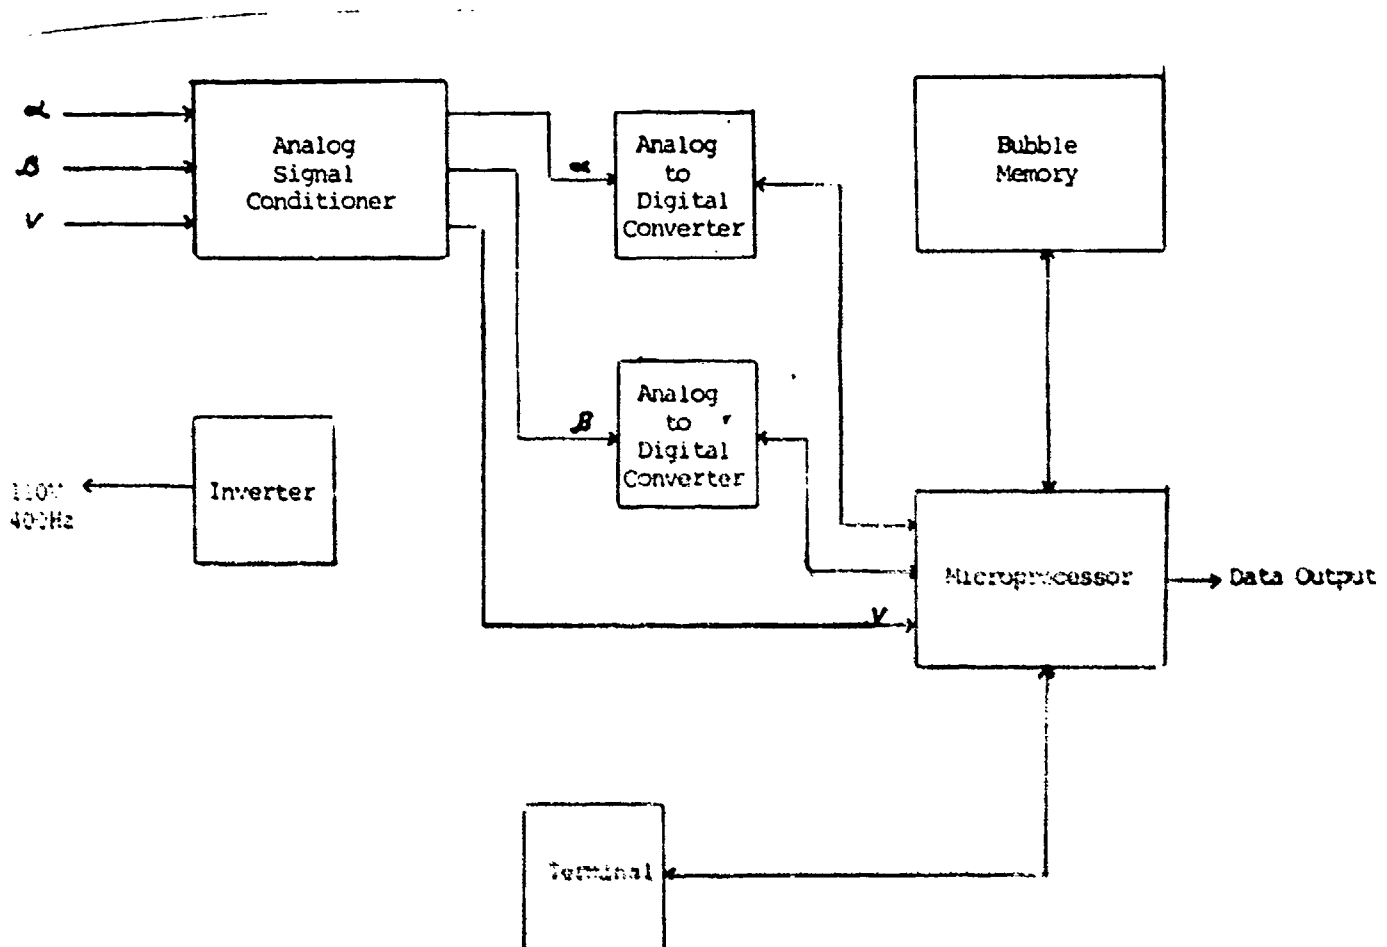
Four magnets mounted on the rear wheel and a pickup coil mounted on the wheel frame are used to measure distance. As each magnet passes the coil, a pulse is induced, thus providing data sampled at equal increments (currently 16.8 cm) along the course surfaces. A block diagram of the on-board digital data-acquisition system is shown in Figure 4.

Figure 4. Data-acquisition system block diagram.

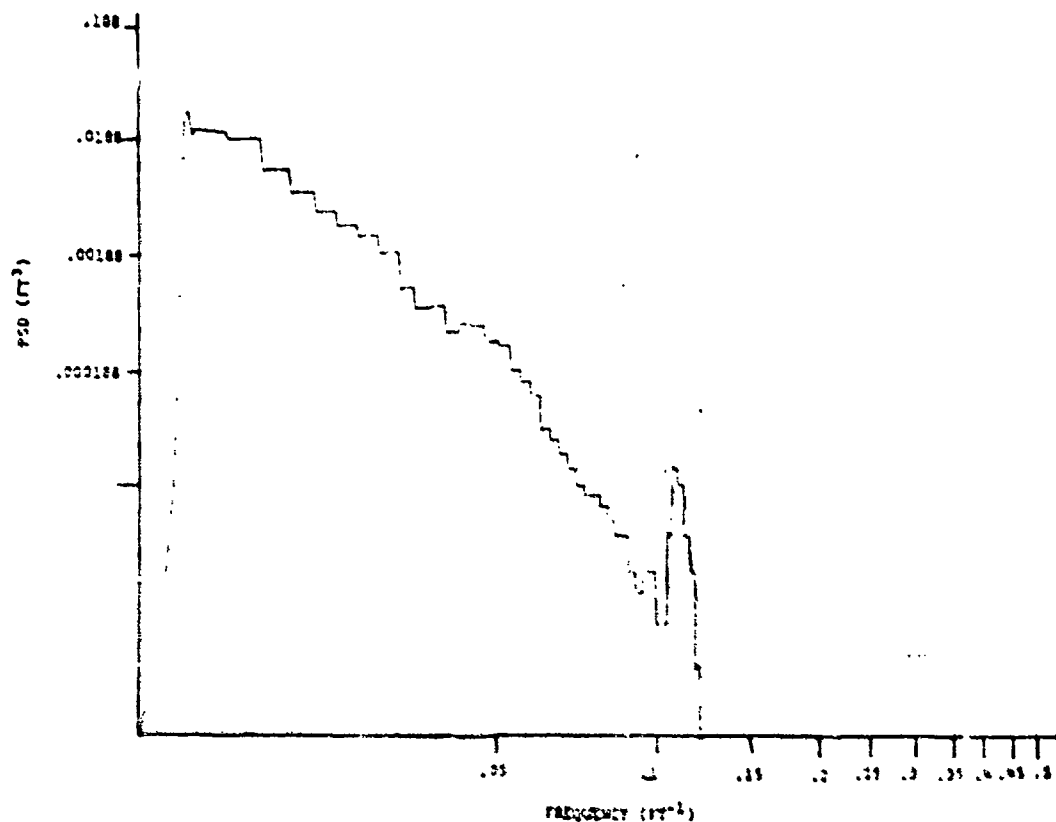
The PSD of this course (fig. 6) is the lowest obtained. The small peak at approximately 0.11 cycle/ft indicates some periodic disturbance with a period of 3 m (9 ft). This disturbance could result from a number of mended cracks that occur every 3 m, or low amplitude undulation in the course with a period of 3 m.

Figure 6. PSD of high speed paved road.

5.1 High Speed Paved Road. This is a 5-km (3-mi) straightaway with banked turnaround loops at each end for tests requiring uninterrupted operations such as cooling tests, operation at high speed, etc. The pavement is continuous asphalt and the course is in the Perryman test area.

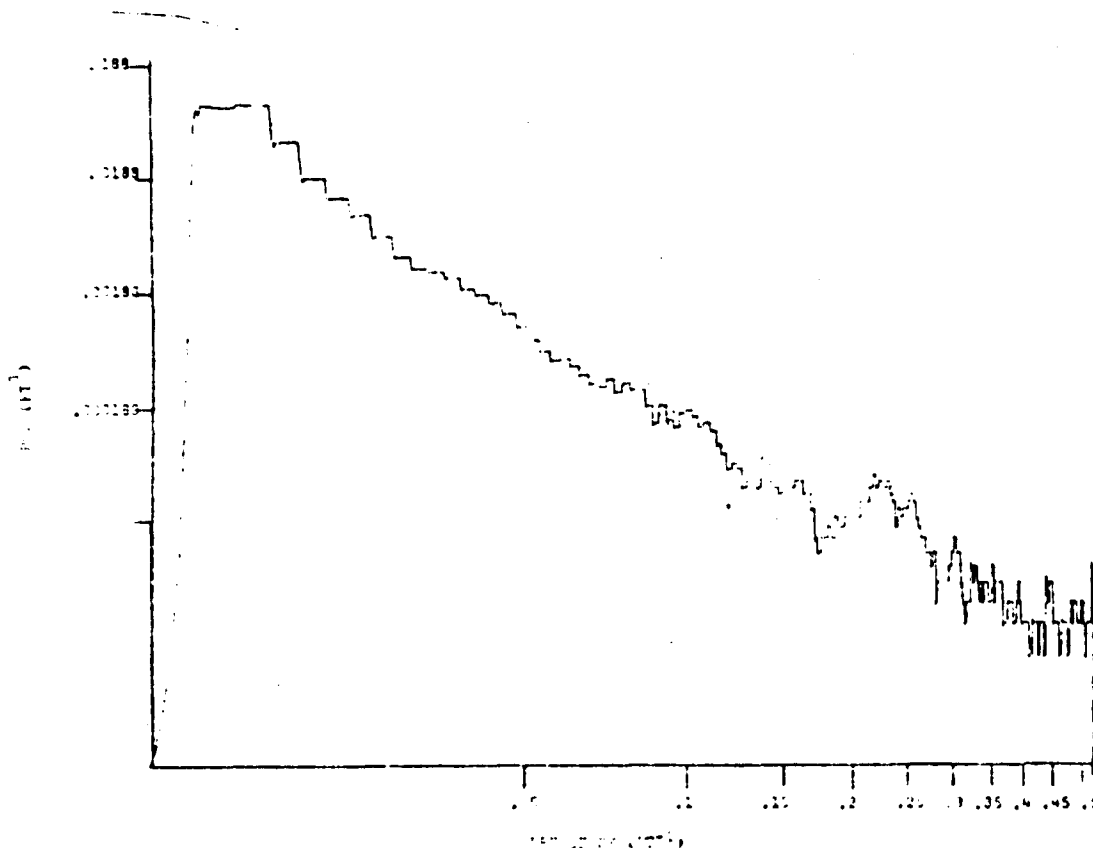
The PSD of this course (fig. 7) is higher than that of the high speed paved road, indicating higher overall roughness. The slope of the gravel road PSD is also more shallow, indicating proportionately more high frequency content.

Figure 7. PSD of improved gravel road.

5.2 Improved Gravel Road. This road is in the Munson test area (see TOP 1-1-011) is a loop of about 3 km (2 mi) with left and right curves. The surface is compacted gravel and dirt, maintained by grading.

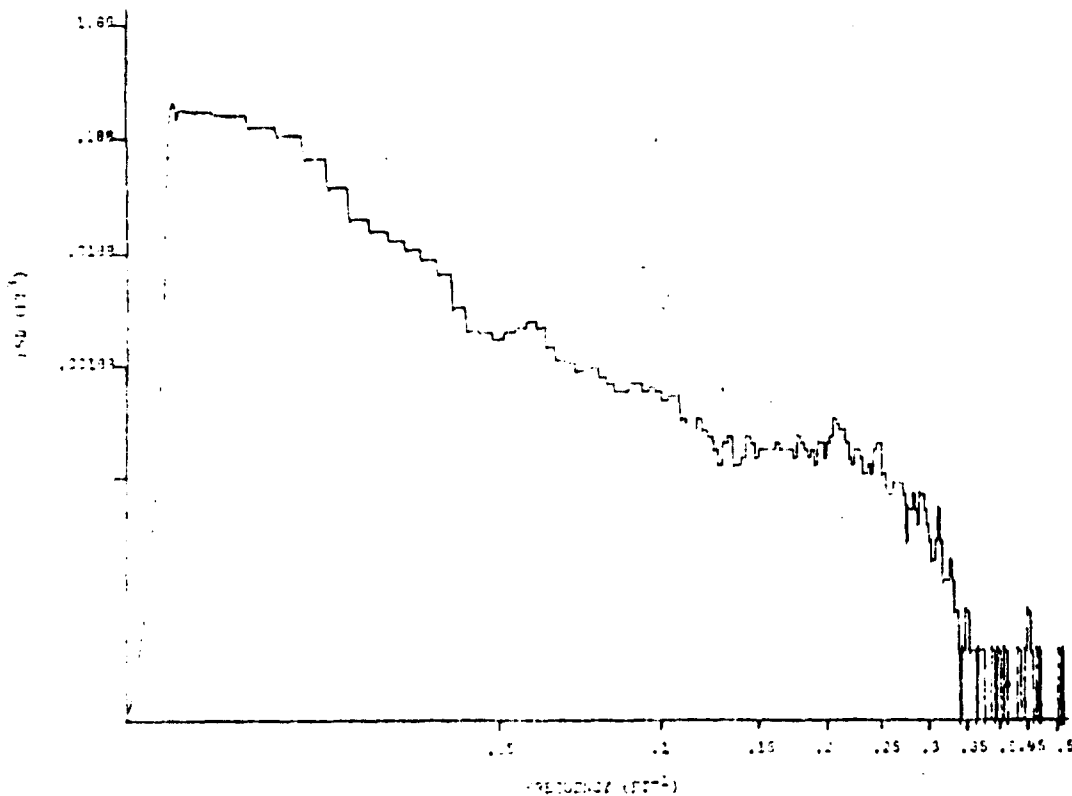
The PSD of this course (fig. 8) is higher than that of the gravel road, indicating more overall roughness. The slopes of both curves are the same, indicating the same proportion of frequency content. In the area between 0.12 and 0.35 cycle/ft, a deviation from the straight line fit occurs.

Figure 8. PSD of secondary road.

5.3 Secondary Road. A 3.8-km (2.4-mi) secondary road in the Perryman area is used for tests of various types of vehicles. This road has sharp and sweeping turns typical of unimproved country roads. The course is maintained by grading and filling with bank gravel and crushed stones as necessary.

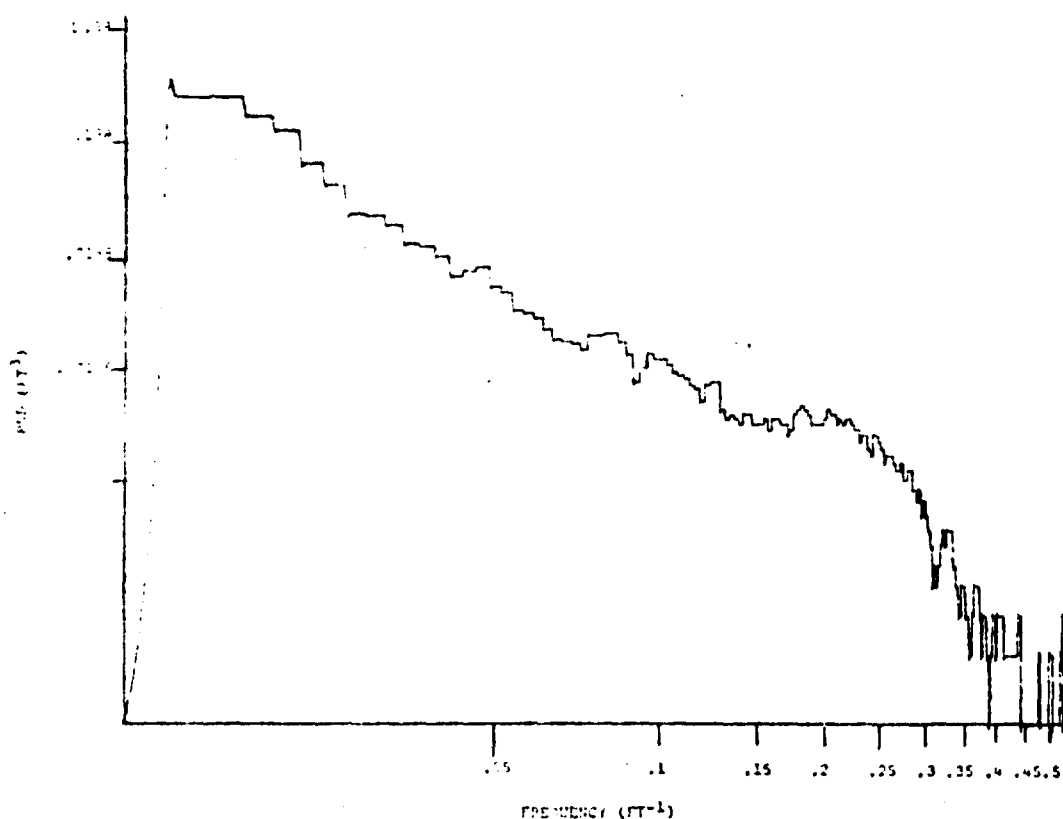
The PSD of this course is shown in Figure 9. This curve has the same slope as secondary road A and a similar bulge in the area between 0.15 and 0.3 cycle/ft. The PSD of this course is slightly higher than that of secondary road A.

Figure 9. PSD of Perryman cross-country course No. 1.

5.4 Perryman Cross-country Course No. 1. This is a moderate course with a substantial roadbed primarily of quarry spall and bank gravel. The loop indicates both sharp sweeping curves, and the surface ranges from smooth to rough; roughness is due to potholes, washboard, and rutting. Potholes and other sharp depressions are normally limited to 15 cm (6 in.) deep by filling with crushed stone. During wet weather, the course as a whole is characterized by light mud which affects wheeled vehicles, mainly by splash.

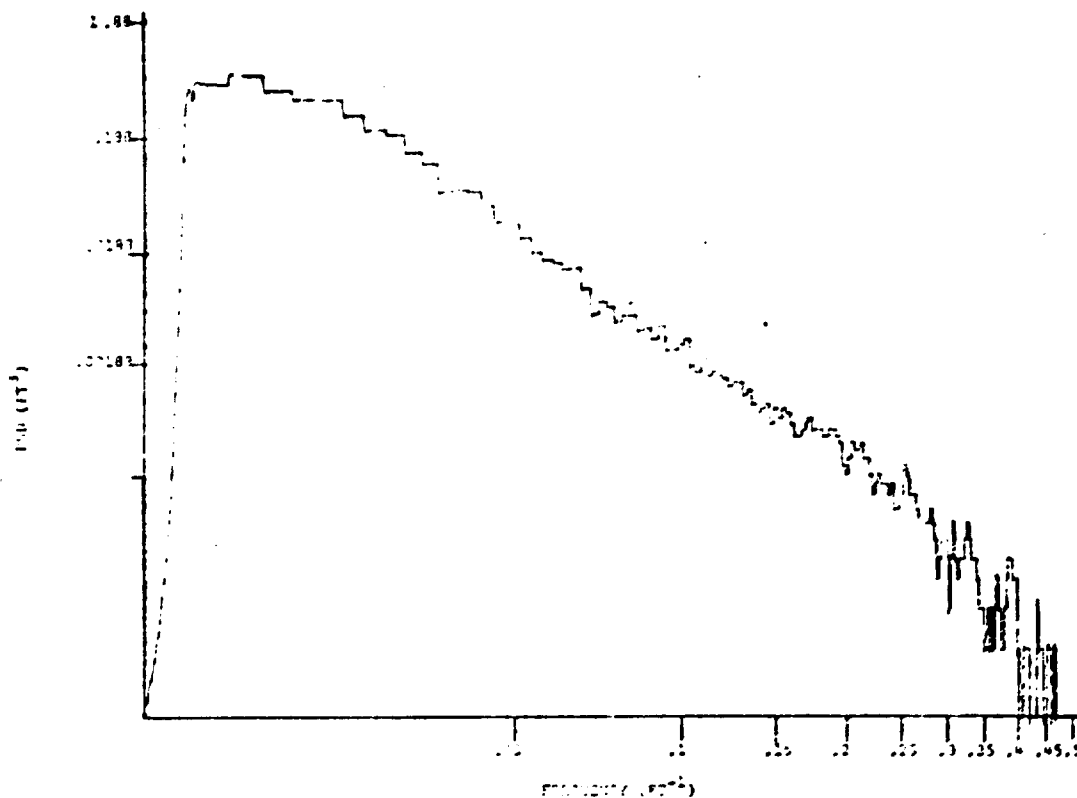
The PSD of this course (see fig. 10) is higher than that of course No. 1. The slope is steeper than that of course No. 1. This indicates that course No. 2 has more overall roughness and proportionately more low frequency content than course No. 1. There is very little deviation from the straight line trend.

Figure 10. PSD of Perryman cross-country course No. 2.

5.5 Perryman Cross-country Course No. 2. This course is laid out in a loop of moderately irregular terrain. The native soil includes sassafras loam, a silty loam with 17.3% clay content, and sassafras silt loam with less than 15% clay. Surfaces range from smooth to rough, and there are sweeping turns. Under wet conditions, severe mud is present; when dry, the course is extremely dusty. Potholes and depressions are limited to 46 cm (18 in.) deep.

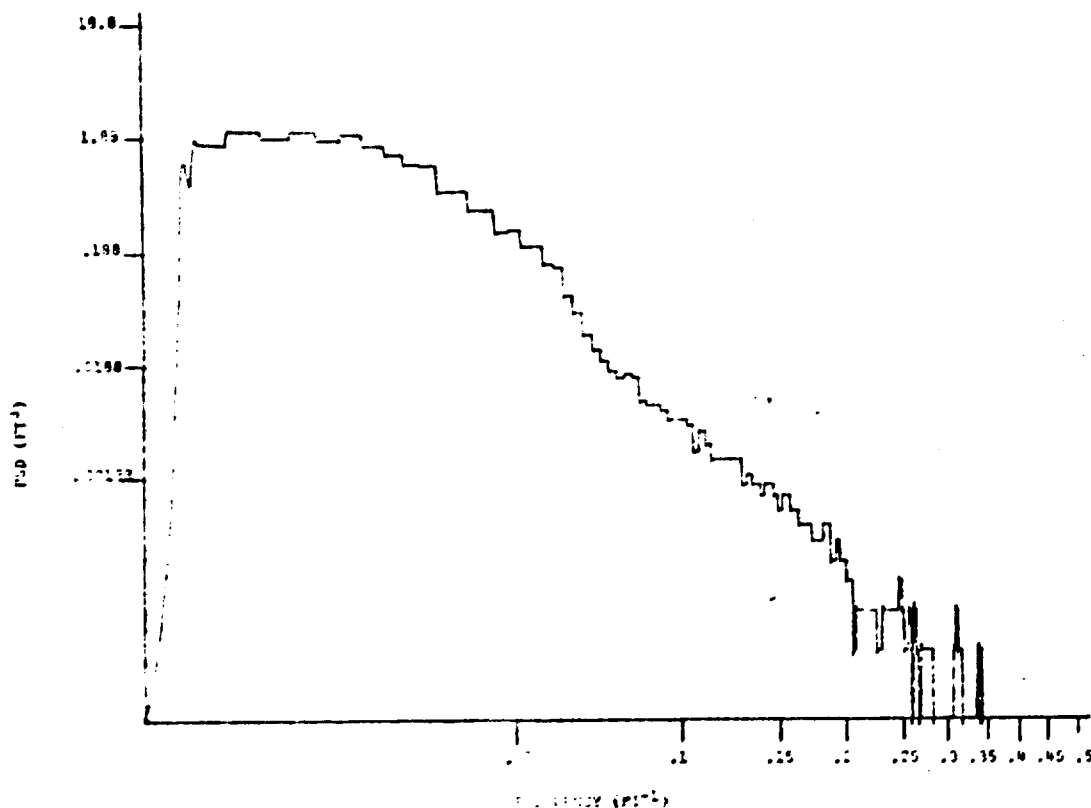
The PSD of course No. 3, shown in Figure 11, is higher than any other and has the steepest slope encountered. The PSD also indicates that course No. 3 has proportionately more low frequency content and overall roughness than course No. 2.

Figure 11. PSD of Perryman Cross-country course No. 3.

5.6 Perryman Cross-country Course No. 3. This is a rough course of native soil similar to the soil of course No. 2. Mud ranges from light (with free water) to cohesive. Although dust is severe when the course is dry, there is always mud in some areas. Much of the course is rough due to many years of test operations of tracked vehicles. Potholes and depressions are limited to 90 cm (36 in.) deep.

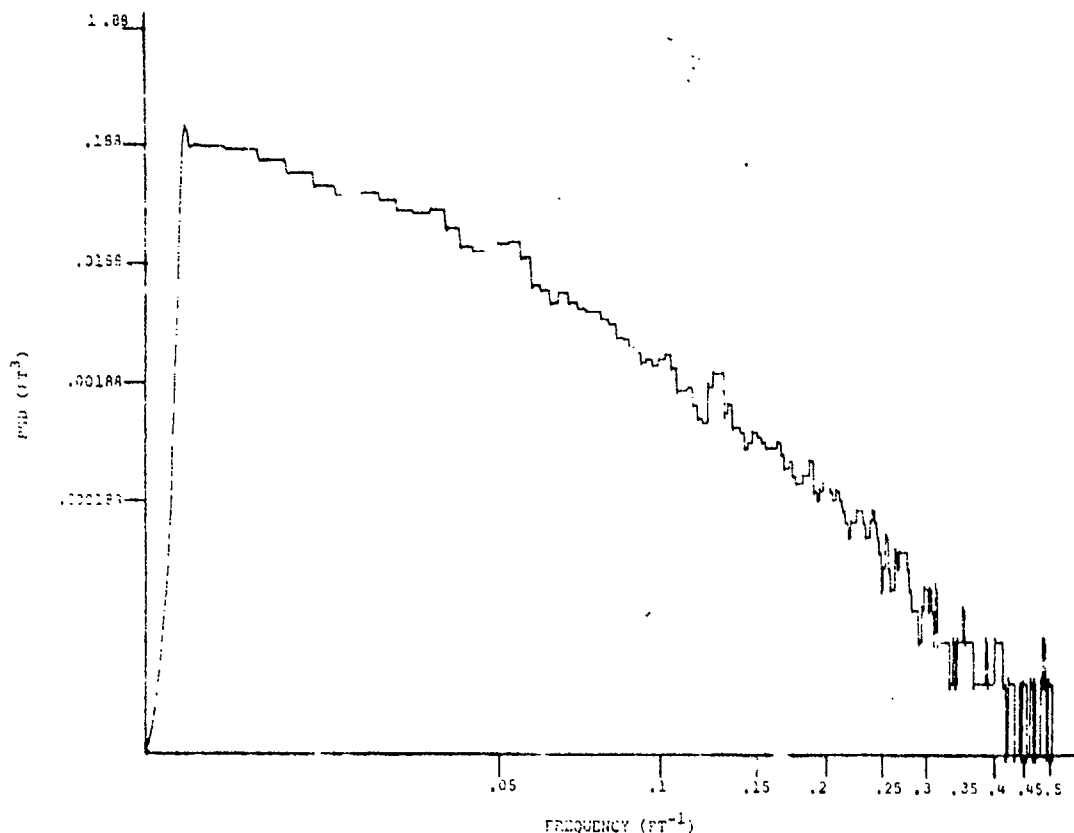
Figures 12 and 13 are PSD plots of Churchville course B which consists of grades up to 27%. The terrain is moderate to rough native soil and stone ranging from muddy to dusty, depending on the weather. The first half of course B is significantly more severe than the second half. The PSD of the first half is about the same as that of Perryman cross-country course No. 2 above the cutoff frequency of 0.1 cycle/ft. The PSD of the second half of course B falls between that of secondary road A and the improved gravel road.

Figure 12. PSD of Churchville course B, first half.

5.7 Churchville Area Courses. These courses are characterized by a series of steep hills with slopes up to 30%. The range of the profilometer analog retrieval system is limited to ± 254 cm (± 100 in.) to afford good resolution of microprofile. This range is considerably less than the height of the hills in Churchville. Because these hills are steep and spaced closely, it is impossible to filter out these terrain changes without filtering out low frequency portions of the microprofile. Although the total PSD plots are shown (see fig. 12 through 14), only the portions above 0.1 cycle/ft should be examined.

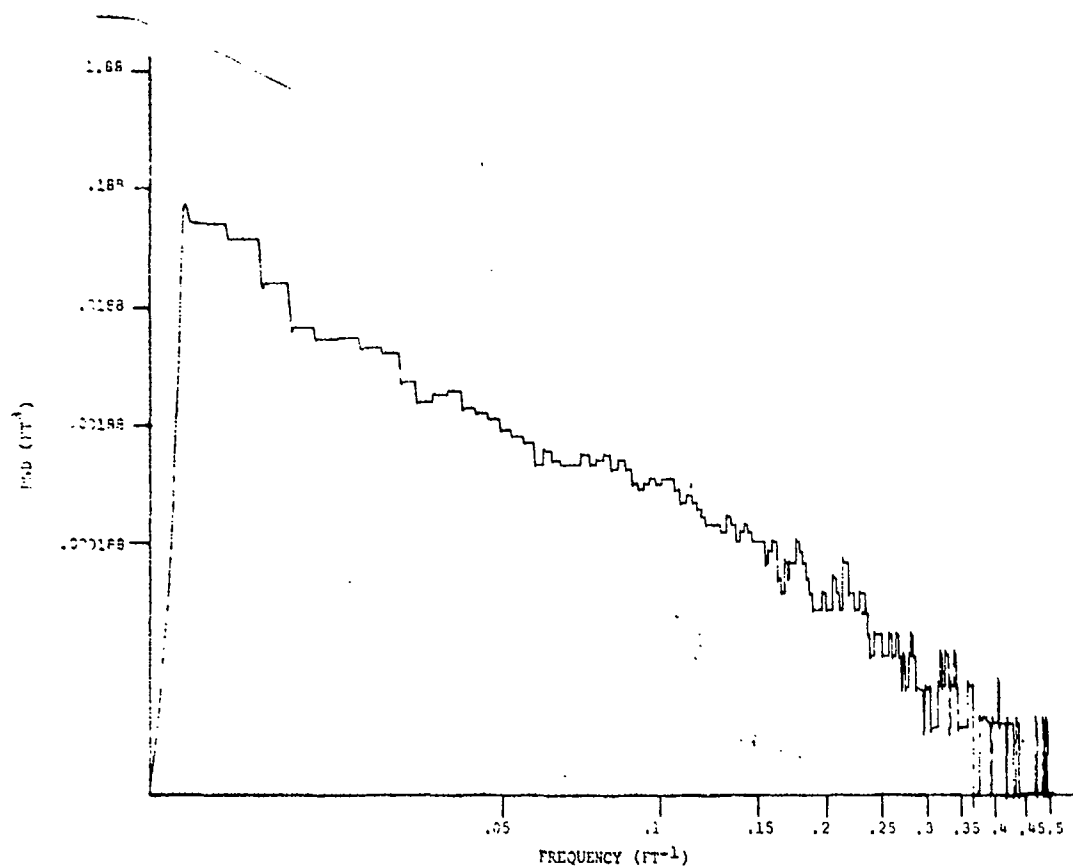
Figure 13. PSD of Churchville course B, second half.

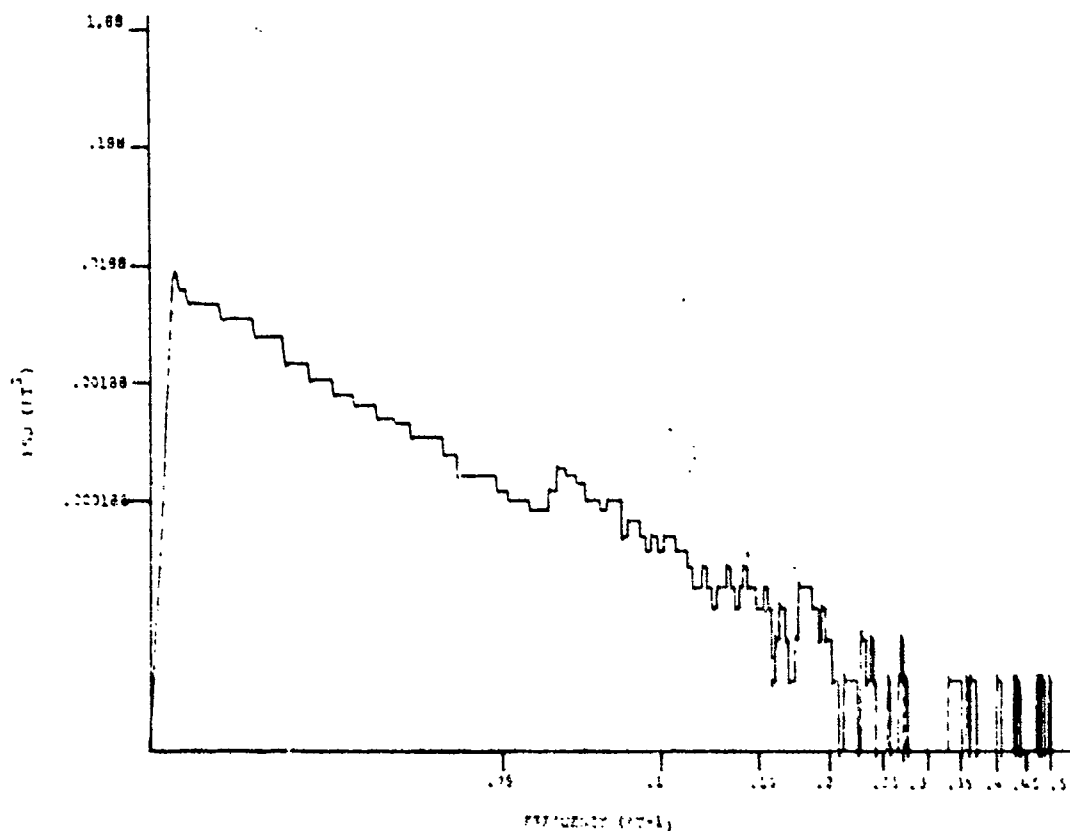
Figure 14 is a PSD plot of Churchville course C which is a 2.4-km (1-1/2-mi) secondary road test course with controlling grades of 10% and turnarounds at each end. This PSD is about the same as that of the improved gravel road above the cutoff frequency of 0.1 cycle/ft.

Figure 14. PSD of Churchville course C.

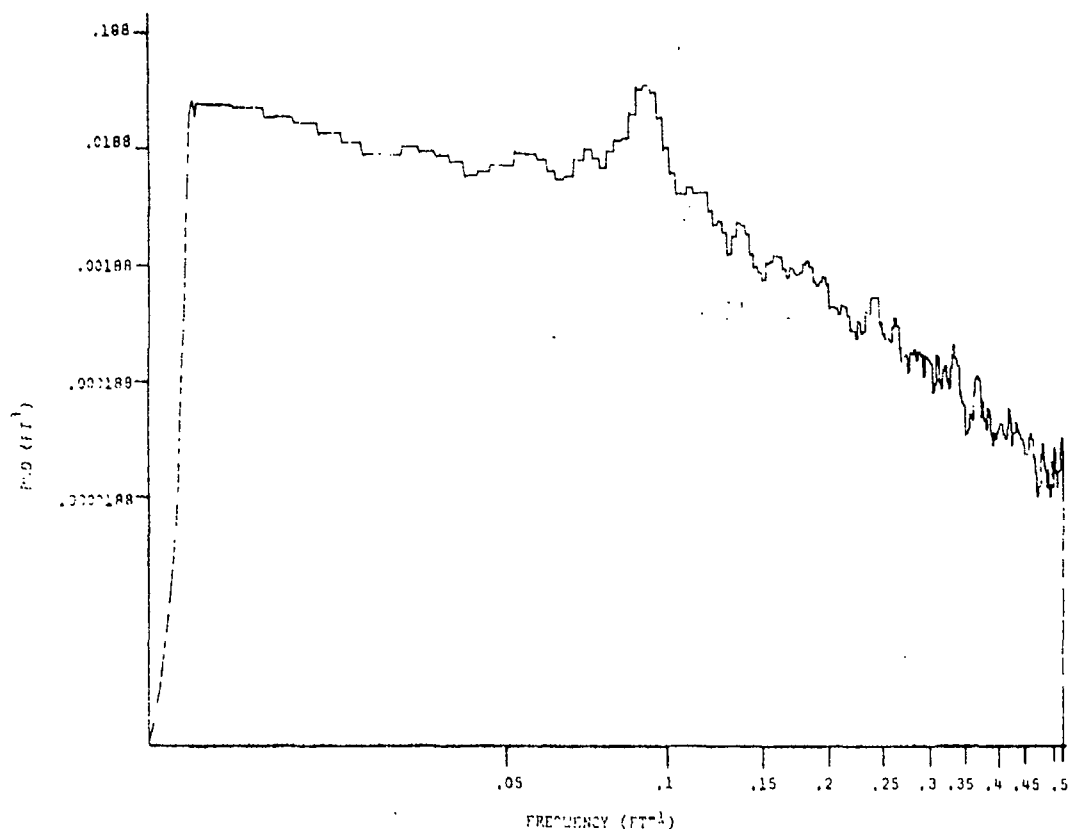
The PSD of the Belgian block course, shown in Figure 15, has the most shallow slope of all the courses examined. This indicates that a large proportion of the energy is high frequency. The peak at 0.1 cycle/ft indicates periodic undulation at this frequency.

Figure 15. PSD of the Belgian block course.

5.8 Belgian Block Course. This is a paved course with unevenly laid granite blocks forming an undulating surface. It duplicates a rough cobblestone road such as is found in many parts of the world. About 1.2 km (3/4 mi) long, the course is useful as a standard rough road for accelerated tests of wheeled vehicles. It is generally included in cycles of courses used for vibration studies. The motion imparted to a vehicle is a random combination of roll and pitch and high frequency vibrations.
